# Asbestos

### Pre-Demolition Survey

Low Raisley Farm, Kelloe, Durham.

**Survey Completion Date: 1/6/2012**  
**Survey Report No: DH6 4PW**

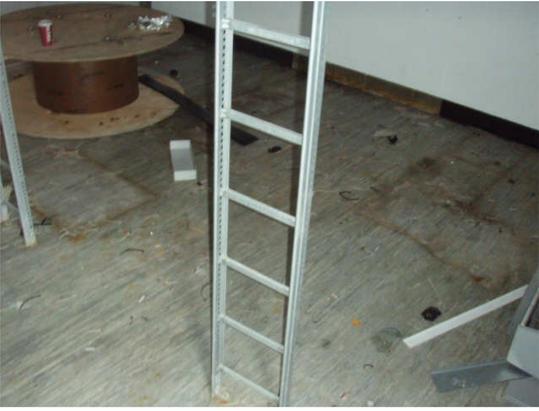
Material		: Bitumen Adhesive
Sample No		: DH6 4PW/001
Extent		: 20 Square Meters
<b>Material Risk Score (HSG 264)</b>		
Asbestos Type	: NADIS	0
Material Type	: Low (ARC/AC)	0
Condition	: Low Damage	0
Surface Treatment	: Uncovered	0
<b>Total Material Risk Score:</b>		<b>0</b>
<b>Priority Risk Score (HSG 264)</b>		
Size of Area	: Room<100 Squared Metres	0
Access	: Infrequent	0
Disturbance	: Minor Disturbance	0
Maintenance	:	0
<b>Total Priority Risk Score:</b>		<b>0</b>
<b>Total Risk Score:</b>		<b>0</b>
<b>Risk Rating:</b>		
<b>Action:</b>		
<b>Comments:</b>	Bitumen adhesive under vinyl.

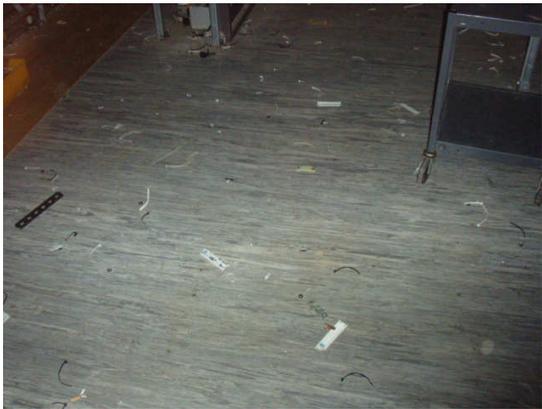
<b>Material Risk Score (HSG 264)</b>	
Asbestos Type	: NADIS 0
Material Type	: Low (ARC/AC) 0
Condition	: Low Damage 0
Surface Treatment	: Uncovered 0
<b>Total Material Risk Score:</b>	<b>0</b>
<b>Priority Risk Score (HSG 264)</b>	
Size of Area	: Room<100 Squared Metres 0
Access	: Infrequent 0
Disturbance	: Minor Disturbance 0
Maintenance	: Unlikely to Disturb 0
<b>Total Priority Risk Score:</b>	<b>0</b>
<b>Total Risk Score:</b>	<b>0</b>
<b>Risk Rating:</b>	
<b>Action:</b>	
<b>Comments:</b>	Bitumen adhesive under vinyl.

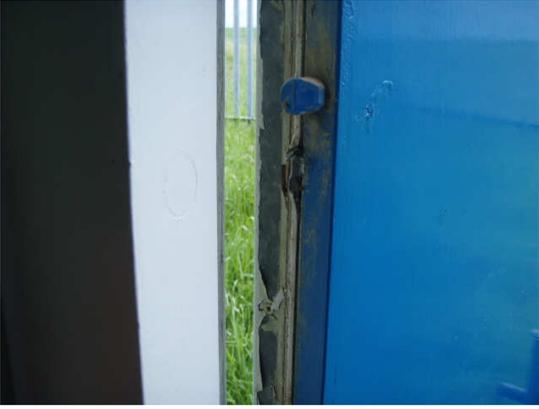
<b>Inspection Code</b>	: DH6 4PW- 5	
<b>Inspection Date</b>	: 1/6/2012	
<b>Surveyor/s</b>	: Darren Cope & Andy Summers	
<b>Building</b>	: Relay Station	
<b>Floor</b>	: Ground Floor	
<b>Room /Area</b>	: Generator Room	
<b>Location</b>	: Fire Door /	
<b>Material Details:</b>

Material		: Putty
Sample No		: DH6 4PW/003
Extent		: 1 Units
<b>Material Risk Score (HSG 264)</b>		
Asbestos Type	: NADIS	0
Material Type	: Low (ARC/AC)	0
Condition	: Low Damage	0
Surface Treatment	: Uncovered	0
<b>Total Material Risk Score:</b>		<b>0</b>
<b>Priority Risk Score (HSG 264)</b>		
Size of Area	: Room<100 Squared Metres	0
Access	: Infrequent	0
Disturbance	: Minor Disturbance	0
Maintenance	: Unlikely to Disturb	0
<b>Total Priority Risk Score:</b>		<b>0</b>
<b>Total Risk Score:</b>		<b>0</b>
<b>Risk Rating:</b>		
<b>Action:</b>		
<b>Comments:</b>	Putty to fire door seal.

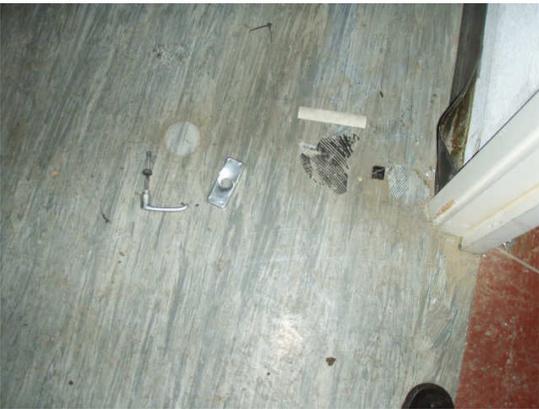
<b>Material Risk Score (HSG 264)</b>	
Asbestos Type	: NADIS 0
Material Type	: Low (ARC/AC) 0
Condition	: Low Damage 0
Surface Treatment	: Uncovered 0
<b>Total Material Risk Score:</b>	<b>0</b>
<b>Priority Risk Score (HSG 264)</b>	
Size of Area	: Room<100 Squared Metres 0
Access	: Infrequent 0
Disturbance	: Minor Disturbance 0
Maintenance	: Unlikely to Disturb 0
<b>Total Priority Risk Score:</b>	<b>0</b>
<b>Total Risk Score:</b>	<b>0</b>
<b>Risk Rating:</b>	
<b>Action:</b>	
<b>Comments:</b>	Bitumen adhesive under vinyl.

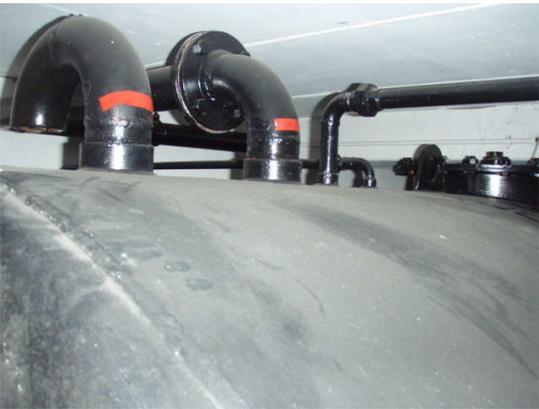
Material		: Compressed Gasket
Sample No		: DH6 4PW/002
Extent		: 1 Units
<b>Material Risk Score (HSG 264)</b>		
Asbestos Type	: Chrysotile	1
Material Type	: Medium (Board/Cloth)	2
Condition	: Good Condition	0
Surface Treatment	: Uncovered	3
<b>Total Material Risk Score:</b>		<b>6</b>
<b>Priority Risk Score (HSG 264)</b>		
Size of Area	: Room<100 Squared Metres	0
Access	: Infrequent	0
Disturbance	: Minor Disturbance	1
Maintenance	: Unlikely to Disturb	0
<b>Total Priority Risk Score:</b>		<b>1</b>
<b>Total Risk Score:</b>		<b>7</b>
<b>Risk Rating:</b>	<b>Medium Priority</b>	
<b>Action:</b>	Remove gasket before the oil tank is removed from site.

The asbestos gasket found to the oil tank must be removed before the oil tank is taken off site. As there is only a single gasket and less than 10Kg of material it can be disposed of during the demolition process.
